NPIC/R-5144/64

PHOTOGRAPHIC INTERPRETATION REPORT

# ACTIVITY AT SA-1 SAM SITES MOSCOW, USSR AUGUST--NOVEMBER 1964

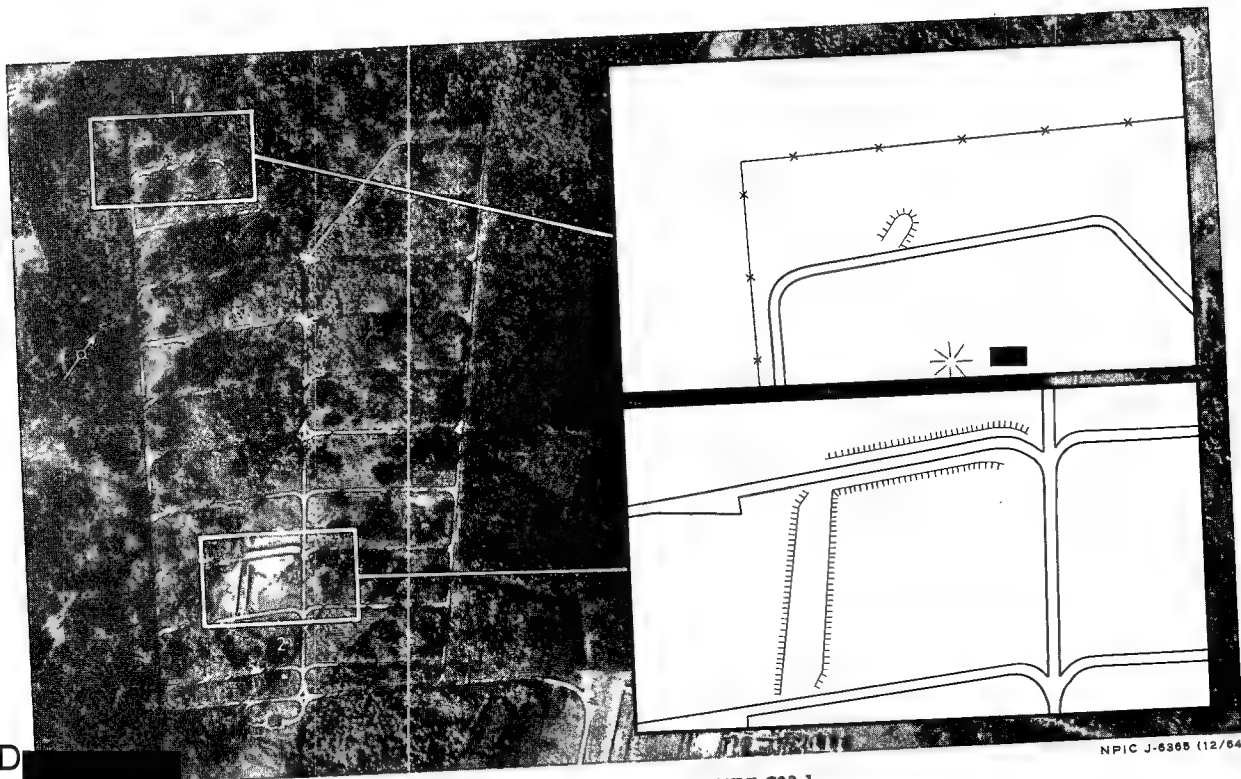
FIGURE 20. MOSCOW SAM SITE C33-1.

A horseshoe-shaped revetment with walls  
80, 45, and 80 feet long was observed on  
photography in the previously reported  
scarred area at the northwest corner of the  
launch area, outside the perimeter road (Fig-  
ure 20, item 1). Orientation of this revetment  
is

An L-shaped earthen revetment was also  
observed between rib roads 2A and 3A (item  
2) in an area of earth scarring that has been  
present since 2/ To com-  
pose the base of the L, parallel walls have  
been constructed on opposite sides of rib road  
3A, the northern wall being 455 feet long, the  
southern one 375 feet long, and the two being  
55 feet apart. The stem of the L-shaped revet-  
ment is perpendicular to rib roads 2A and 3A,  
with an opening at the northwest corner to per-

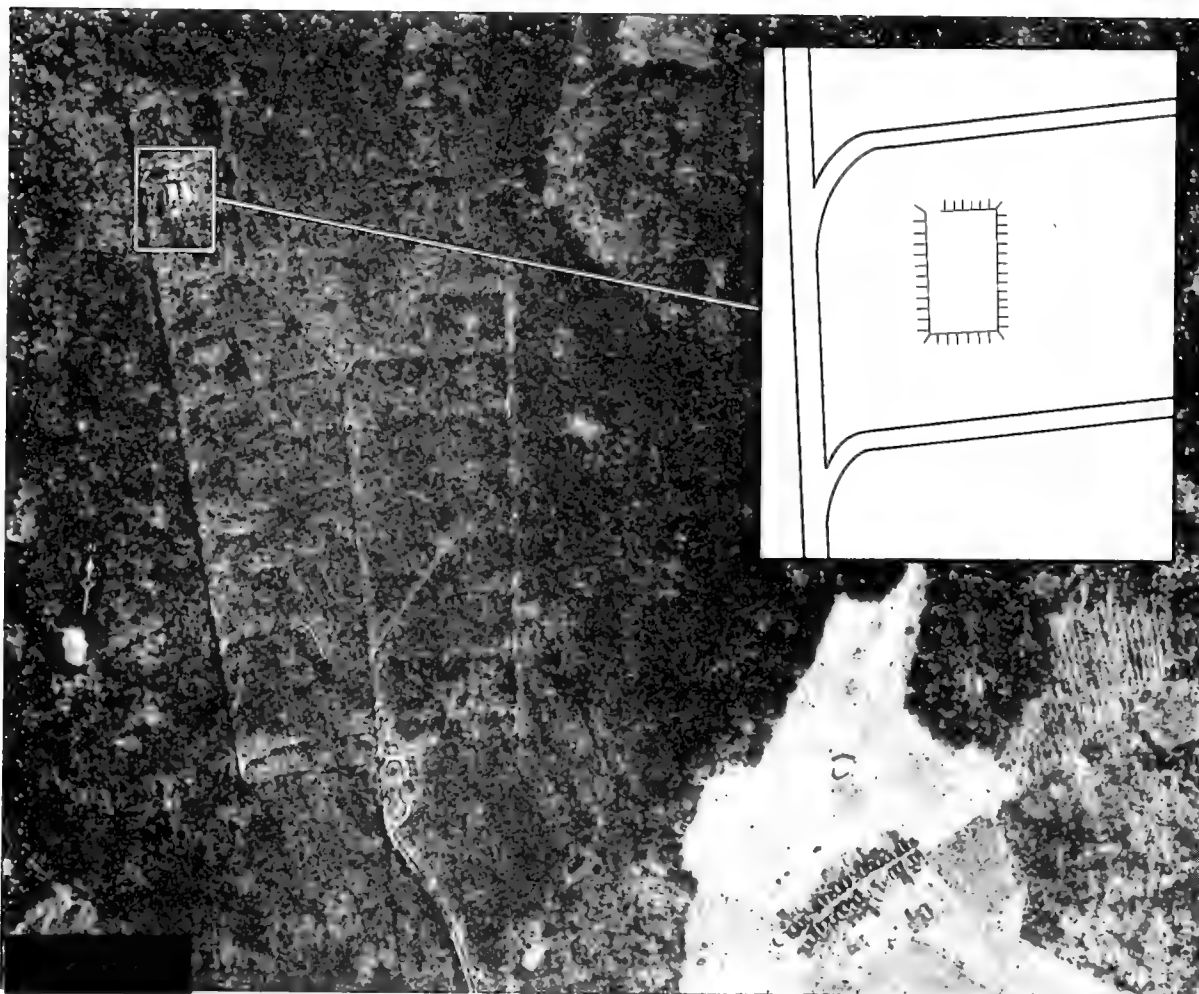
FIGURE 21. MOSCOW SAM SITE C35-1.

the previously reported earthen wall<sup>1</sup> between rib roads 10A and 11A (Figure 21, item 1), in effect creating a four-sided revetment with two walls 205 feet long and two 120 feet long. Walls are 20 feet wide at the base and estimated to be [REDACTED]. A 30-foot opening in the north wall provides access into the revetment, whose orientation is [REDACTED].

An irregular earthen revetment was also  
observed on the [REDACTED] photography in  
the previously reported scarred area between rib  
roads 2B and 3B (item 2). The five-sided  
revetment has walls 200, 185, 175, 85, and 75  
feet long; all are 20 feet wide at the base and  
approximately [REDACTED].

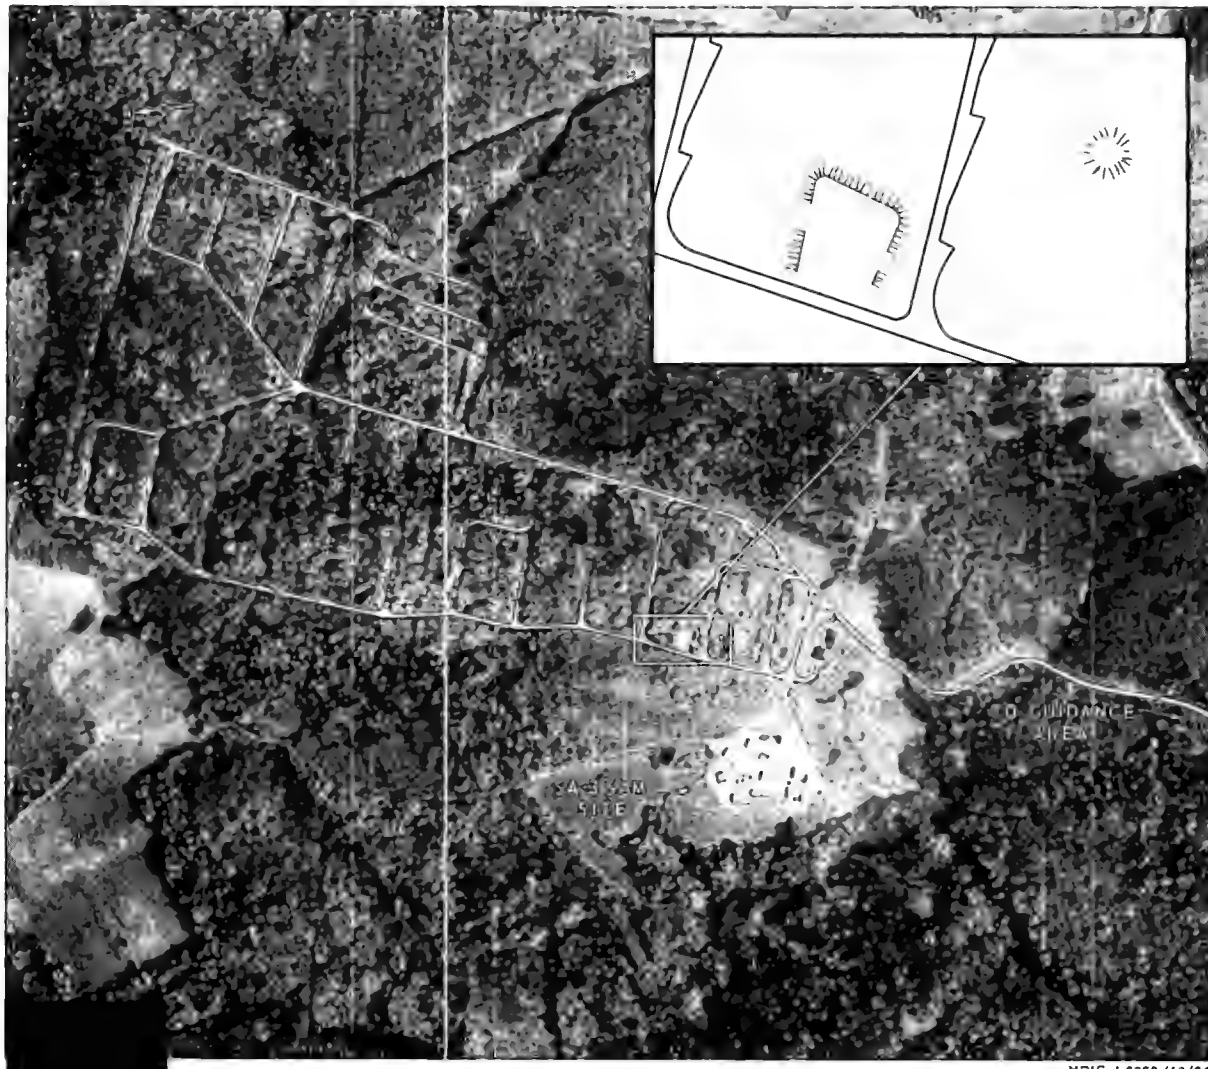
FIGURE 24. MOSCOW SAM SITE E02-1.

No missile equipment was discernible on the [REDACTED] coverages. No changes were observed in the guidance or support areas.

An SA-3 SAM site of the F configuration was first observed on the [REDACTED] photography adjacent to the southwest corner of the SA-1 launch area. The site was not present on the [REDACTED].

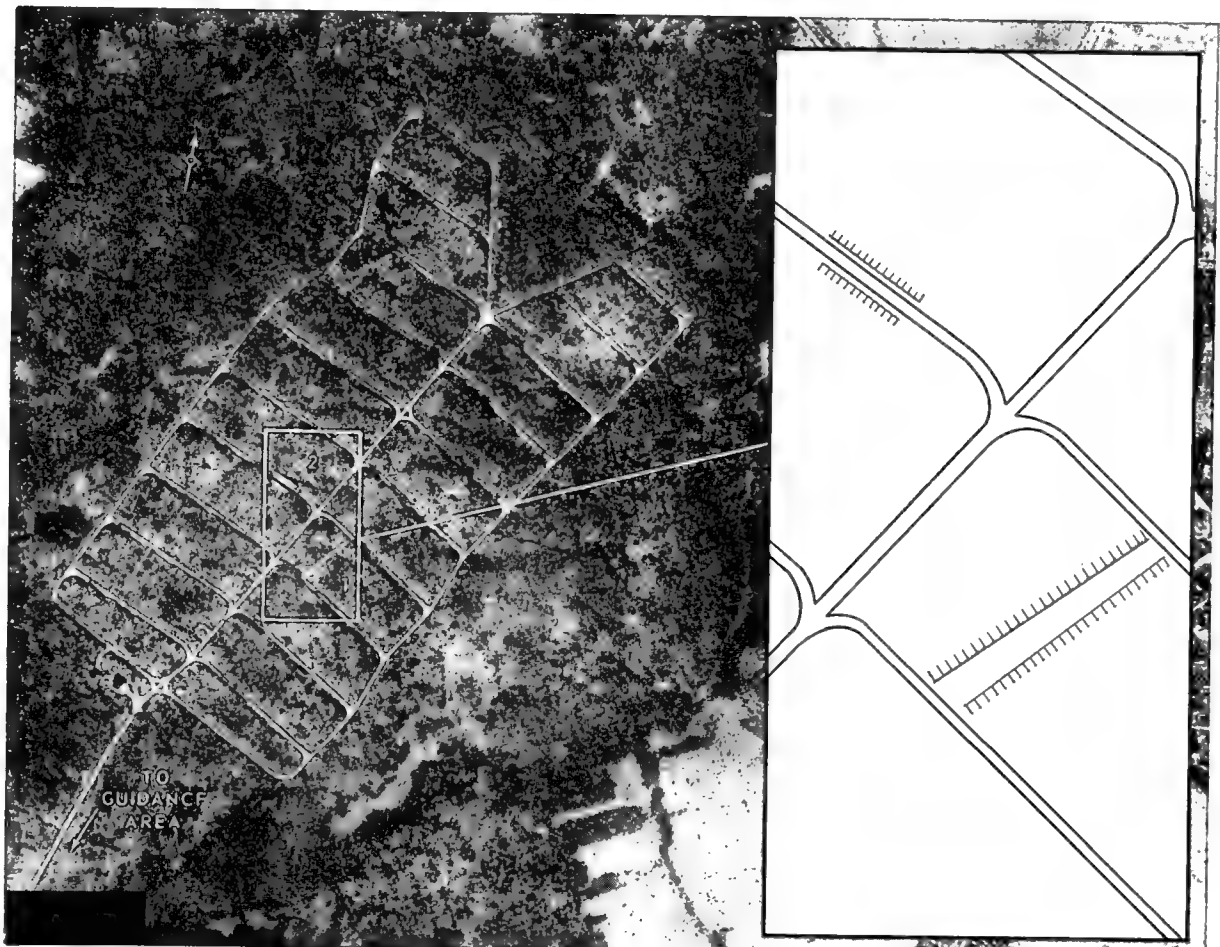
FIGURE 25. MOSCOW SAM SITE E03-1.

Two parallel earthen walls (Figure 25, item 1) had been constructed by [REDACTED] between rib roads 3B and 4B in the area of previously reported scarring observed on [REDACTED] coverage. 1/ Walls are 435 feet long, 20 feet wide, and approximately [REDACTED] forming a drive-through revetment with an orientation of [REDACTED]

Two parallel earthen walls were observed on [REDACTED] photography on opposite sides of rib road 4A (item 2). The walls are 310 feet long, 20 feet wide at the base, and

Missile equipment was observed within the launch area on the [REDACTED] coverages. No changes were apparent in the support or guidance areas.

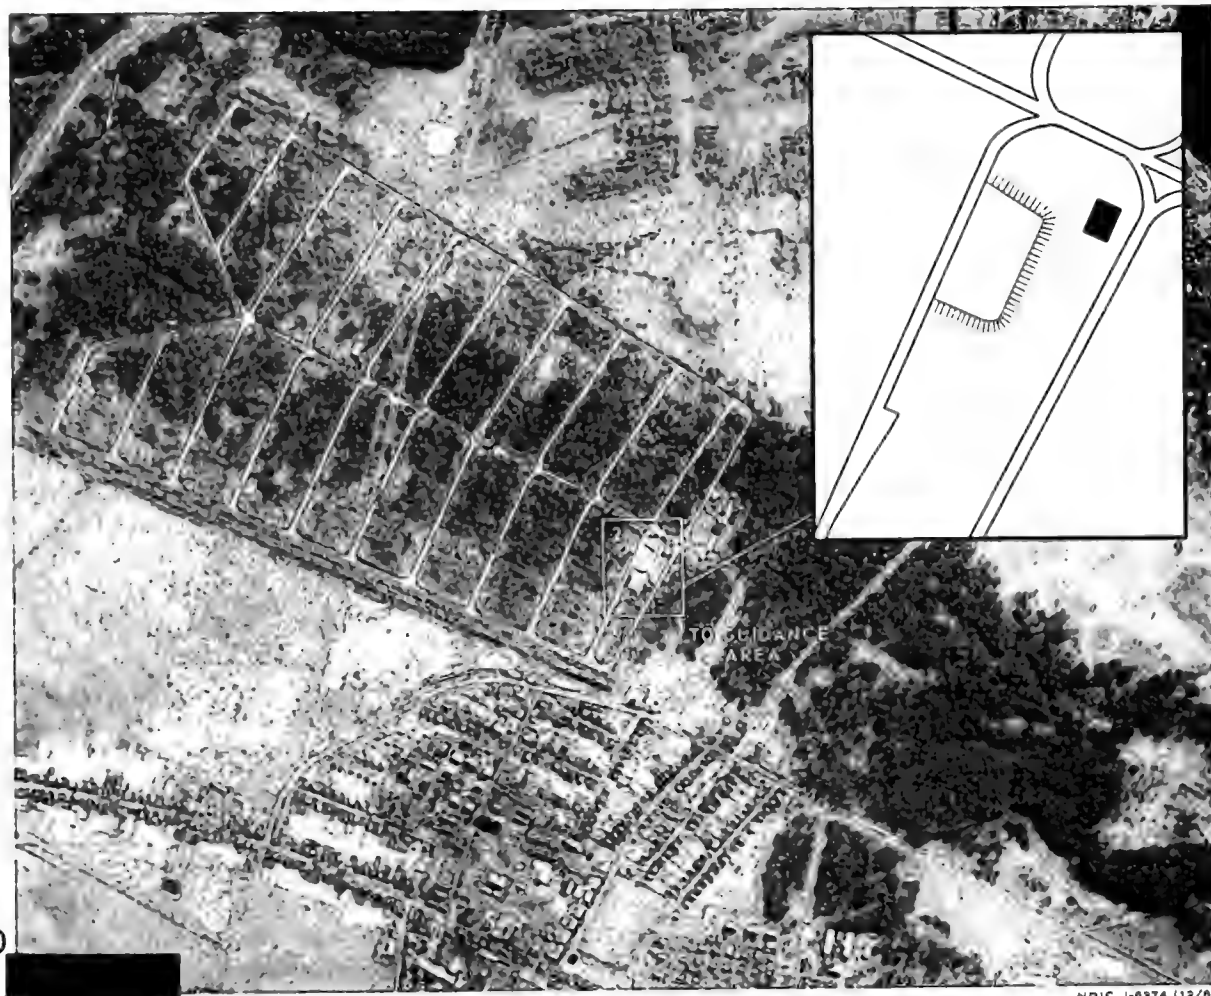
FIGURE 29. MOSCOW SAM SITE E10-1.

shaped earthen revetment was identified on the west side of rib road 1A (Figure 29, item 2). The revetment walls are 110, 190, and 115 feet long, 20 feet wide at the base, and approximately 15 feet high. Orientation of the revetment is [REDACTED].

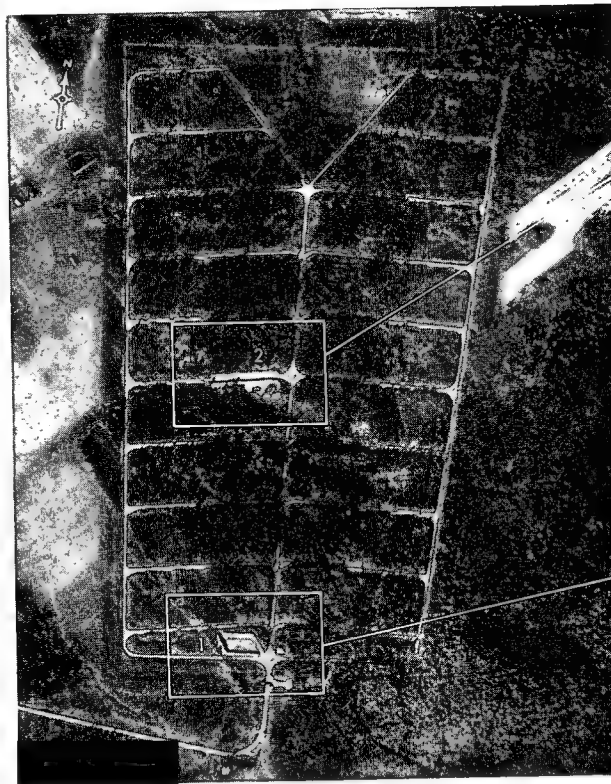
FIGURE 46. MOSCOW SAM SITE E36-1.

On the same coverage, two parallel earthen walls were observed in the previously reported scarred area along rib road 5A (item 2). The walls were constructed by pushing earth toward the rib road, creating a drive-through revetment whose walls are 580 feet long, 50 feet apart, 20 feet wide at the base, and approximately [REDACTED]. Orientation of the revetment is [REDACTED].

Missile equipment was observed in the launch area on the [REDACTED] coverage.

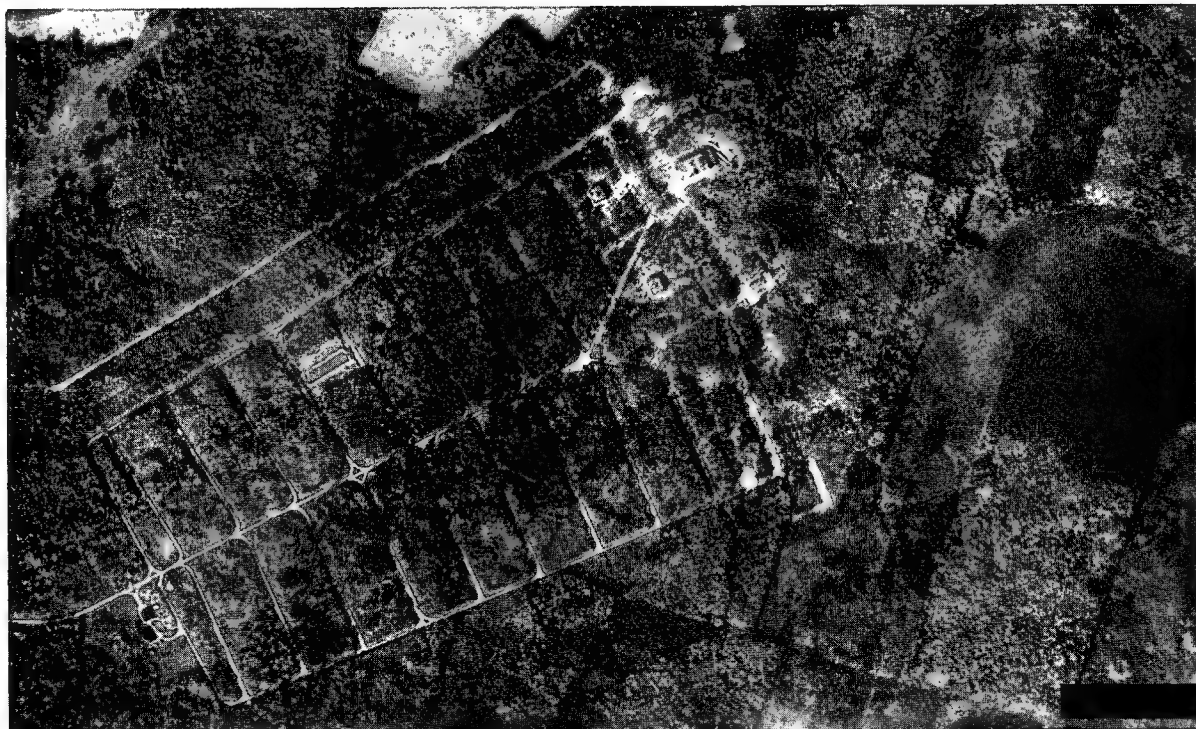
FIGURE 47. MOSCOW SAM SITE E05-1.

25X1D Three clearings, probably the preliminary construction for a second triad of buildings, were apparent in the northeast corner of the launch area on photography of [REDACTED]. The largest clearing (Figure 47, item 1) is 2,150 feet south of the largest building of the existing triad. The clearing covers an area of approximately 400 by 170 feet; the two smaller clearings, in line with the smaller buildings of the existing triad, measure 125 by 115 feet and 125 by 85 feet. The clearings form a triangle with two sides 850 feet long and one side 910 feet long, which is somewhat smaller than the existing triangle whose sides are 1,025, 855, and 815 feet long. Review of earlier photography indicates no sign of the clearings in [REDACTED].
